TECHNOLOGIC PAPERS

No. 82

FAILURE OF BRASS. 1.—MICROSTRUCTURE
AND INITIAL STRESSES IN WROUGHT
BRASSES OF THE TYPE 60 PER CENT
COPPER AND 40 PER CENT ZINC

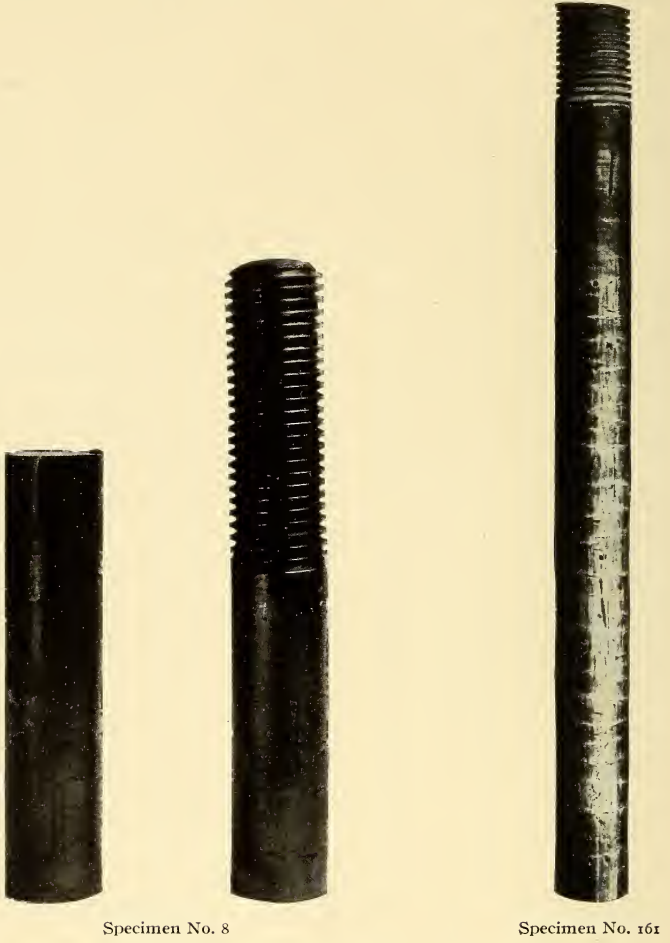
FIG. 1.—Season cracked brass rod

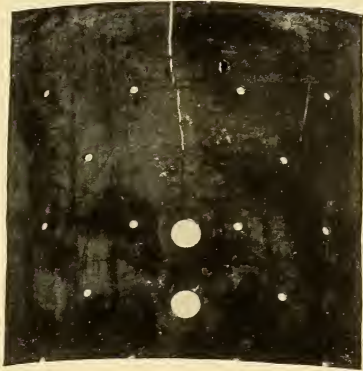
FIG. 2.—*Season cracked brass*
Specimen No. 125

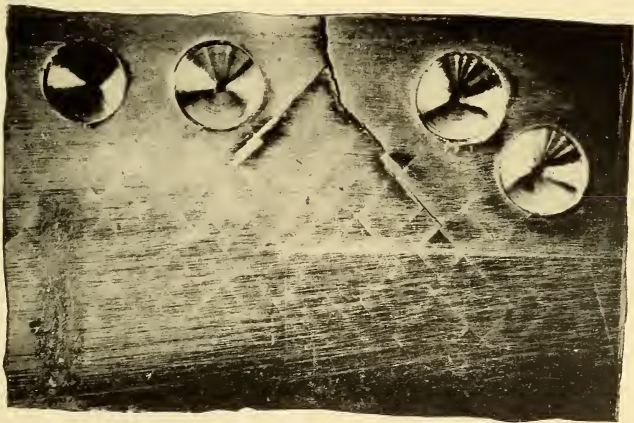
FIG. 3.—*Season cracked ladder side bar*
Specimen No. 211

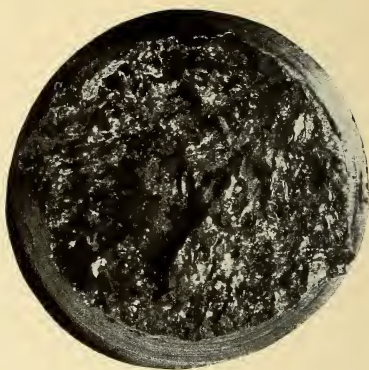
FIG. 5.—*Fracture*
Material 35 $\times 1$

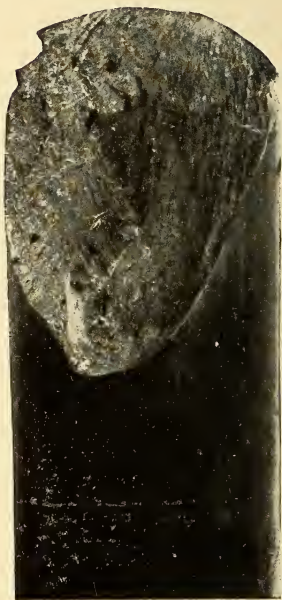
FIG. 7.—*Fracture*
Material 65 $\times 1$

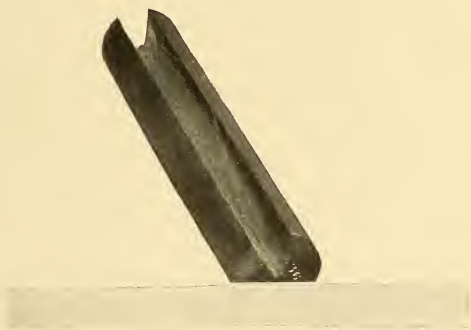
FIG. 10.—*Specimen for rapid initial stress test on bars*

not advisable, as the compression of the specimen by it caused in itself an appreciable elongation. It was necessary to use a special device, which consisted of a piece of one-fourth inch steel wire bent to a right angle. One arm was bolted to the face plate of the lathe and the other went through a transverse hole in one end of the brass specimen and was lightly secured therein by bolts. This arrangement, it was observed, introduced no errors in the measurements.

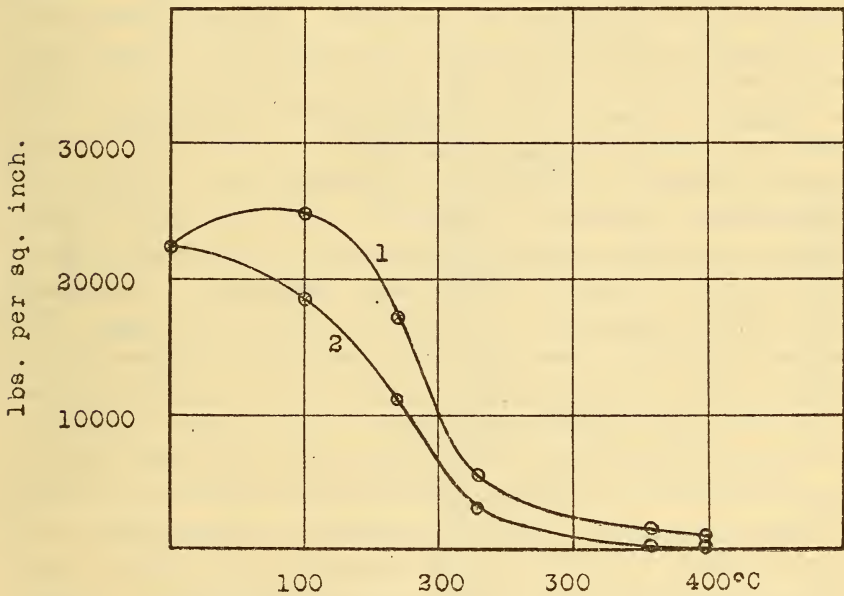
FIG. 11.—Effect of annealing on the average initial stresses in a manganese bronze

Abscissas	Annealing temperatures in °C
Ordinates	Average initial stress in pounds per square inch
Curve 1	For 1 hour's annealing
Curve 2	For 7 hours' annealing

It is interesting to notice that the stresses in the specimen 23 A were not so completely removed by annealing at 600° C for one-half hour as those in No. 136 by annealing for one hour at 300° to 400° C.

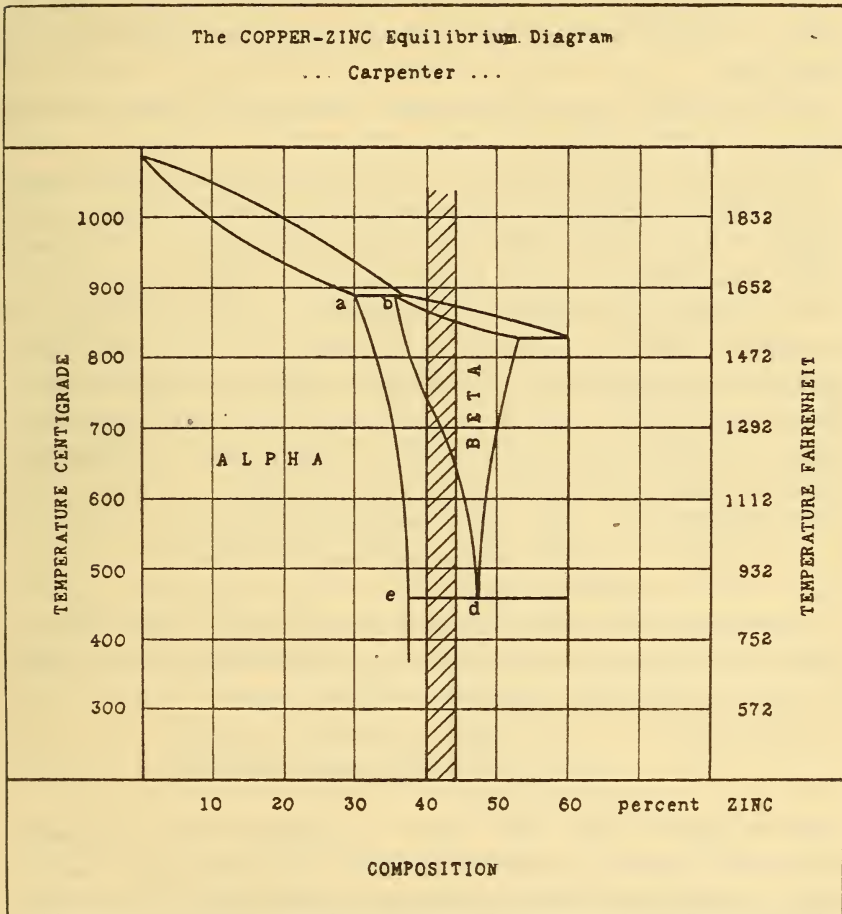
FIG. 12.—Portion of the Cu-Zn equilibrium diagram according to Carpenter
The shaded strip represents the range of compositions of brasses investigated

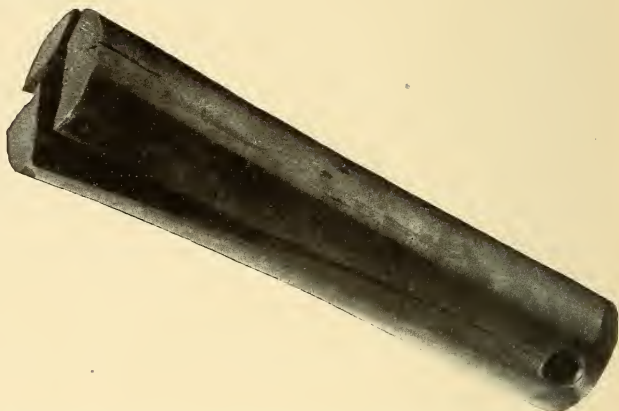
FIG. 13.—Material No. 169 after immersion in water for two weeks

Within this time (and afterwards) only the specimens marked with an asterisk, Nos. 3, 136, 158, 160, 167, 169, 171, and 173, cracked or showed any sign of fissure. Nos. 158 and 160 contained, after the test, transverse cracks only, No. 171 one longitudinal crack, and the others both. These cracks appeared generally in less than five minutes. From this it appears that only those materials crack under the mercurous-nitrate acceleration test which have at the surface tensional stresses above a certain value, which may provisionally be set at 30 000 pounds per square inch for the type of materials tested. Materials having compression stresses at the surface, even when these are large (No. 164 had 32 000 pounds per square inch compression at the surface), are not affected in this test.
